# Criteria for Controlled Close Proximity Blasting at the Oroville Dam Spillways and Flood Control Structure

John Lemke, PE, GE; Mike Driller, PE, GE; Mark Schultz, PE, SE, GE; Gordon Revey, P.Eng.; and  
Amin Islam, PE

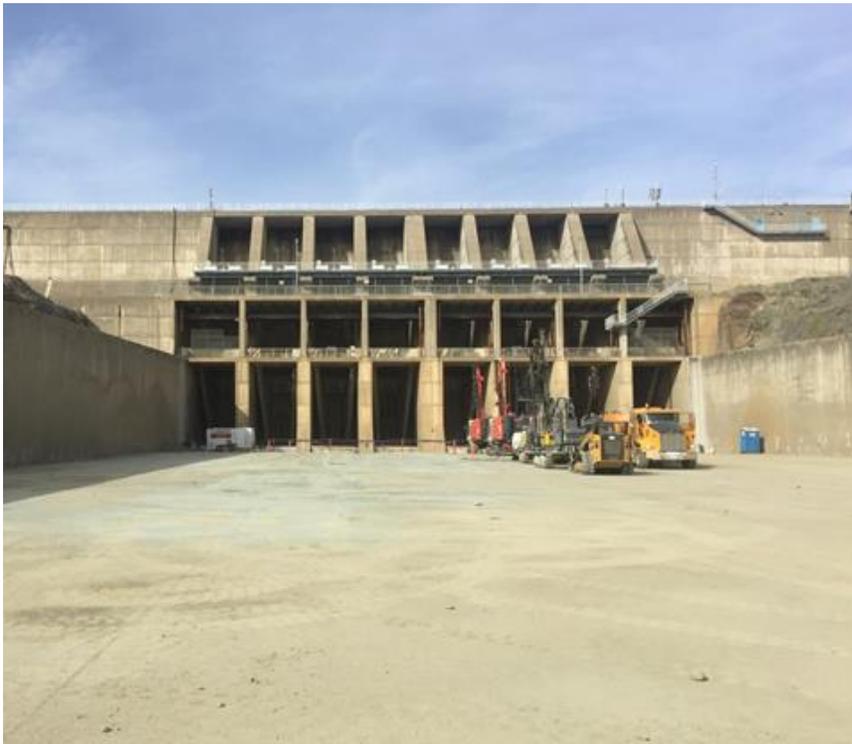
Figure 1. Main Spillway Slab and Gate Structure.

The Oroville Dam, located east of Oroville, California, on the Feather River, is a 770-foot high earth embankment dam constructed between 1961 and 1968. The dam has two spillways including the main spillway structure, referred to as Flood Control Outlet (FCO), and an Emergency Spillway consisting of monoliths and ogee weirs intended to pass extreme flows above the FCO capacity of approximately 300,000 cfs. The main spillway is a rectangular chute about 180 feet wide and about 3050 feet long with approximately 20 to 34-foot-high walls. Figure 1 shows the FCO gate structure and upper chute. The thickness of the chute invert slab was varied from about 1.5 to 4 feet, with #5 bars on 12-inch centers, both directions. Lateral drains were installed beneath the invert without additional excavation, which reduced the slab thickness to just seven inches over the drain lines.

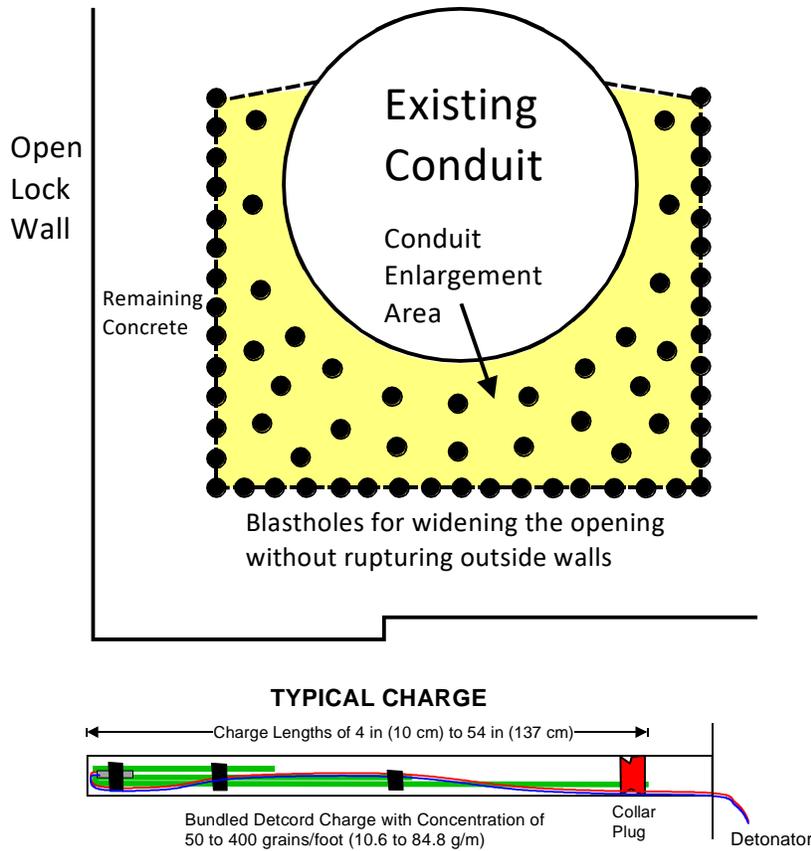
Figure 2. Typical configuration of blastholes and charges used to Enlarge Conduits at Lock and Dam No. 1.

program by Tart, Oriard and Plump (1980) [5] was designed to evaluate the feasibility of using very light charges configured from detonating cord to enlarge and modify water flow conduits at Lock and Dam No. 1 on the Mississippi River. For this work, the challenge was to develop charges for holes drilled parallel to the existing conduit that would sequentially break concrete into the opening without damaging the remaining concrete wall. The general configuration of the extremely careful blasting that was ultimately applied to expand the conduits is shown in Figure 2.

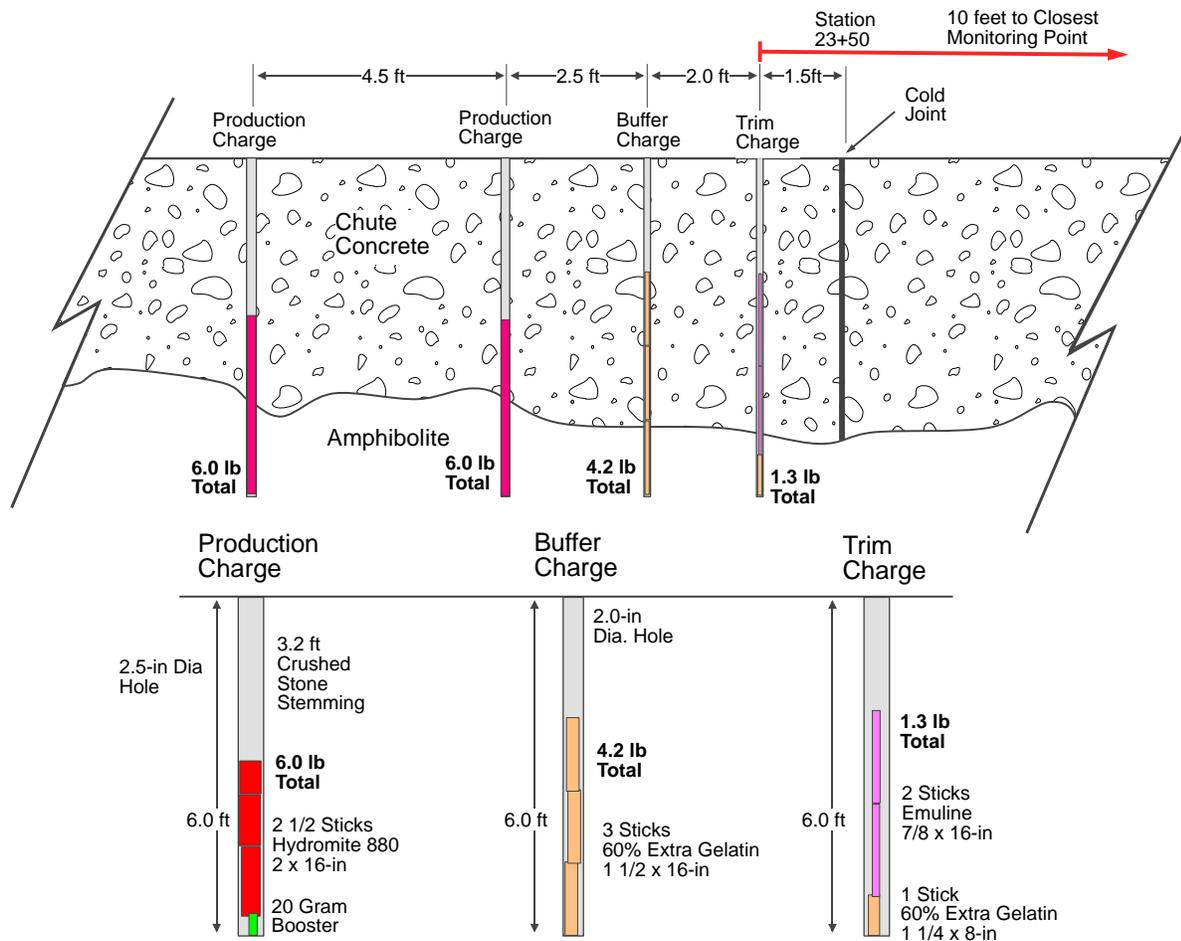
Figure 3. Test Blast Charge Configurations.

Two separate tests blasts were designed for this study. In Test Blast 1, as shown in Figure 3, decoupled charges were used in the closest holes to minimize the potential for damage past a cold joint located 1.5 feet from closest holes. One and a half-inch and 7/8-inch diameter charges were used in respective buffer and trim holes. Two-inch diameter emulsion charges were used in the remaining holes in Blast 1 and in all the holes used in Blast 2. Charge-per-delay in Blast 1, initiated with electronic detonators was 6.0 pounds per delay. Conventional shock-tube detonators were used in Blast 2 with a charge-per-delay of 12 pounds.

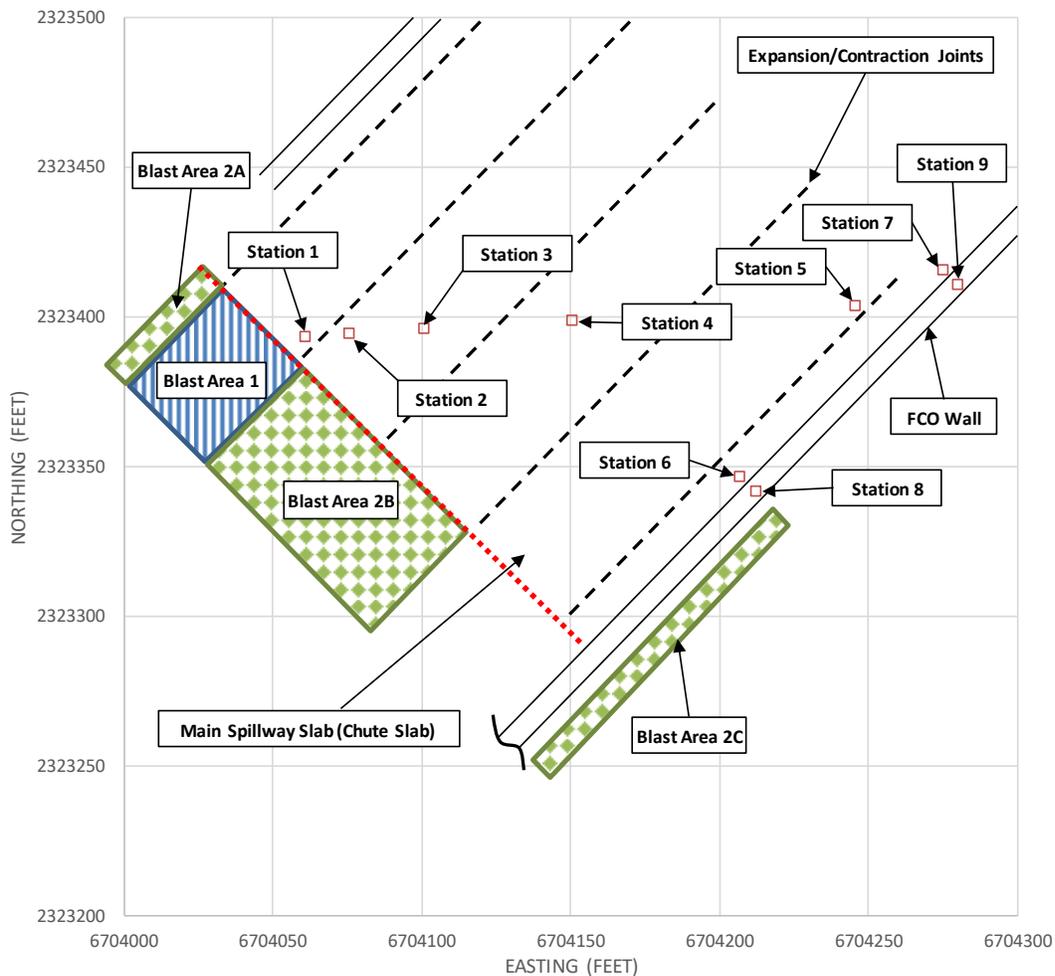
Figure 4. Plan View of Blast Instrumentation Layout on Main Spillway Slab.

Accelerometers and strain gages were installed on the main spillway slab at 9 stations located at different distances from the blast areas as shown on Figure 4. A total of 19 accelerometers and 12 strain gage sensors were mounted to the surface of the chute invert slab and FCO wall. Sensors were mounted to the chute invert slab and FCO wall with the following orientations: (a) longitudinal direction parallel to the spillway chute slab and parallel to the FCO walls, (b) transverse direction parallel to spillway chute slab and perpendicular to the FCO walls, and (c) vertical direction perpendicular to the spillway chute slab.

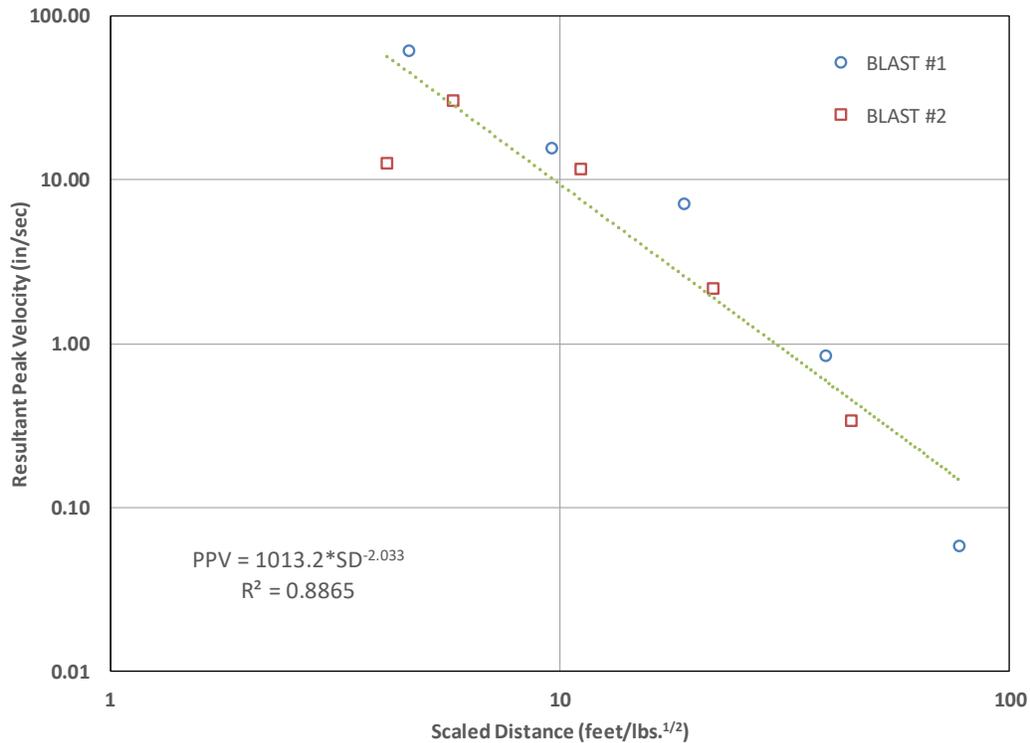
Figure 5. PPV Attenuation in the Concrete Spillway Chute Slab.

Vibrations from two blast events were monitored on June 30, 2017 using instruments installed on the main spillway slab. Velocity time histories were calculated by integrating acceleration records, and PPV values were calculated from the velocity results for each measurement direction. A relationship between the resultant PPV and scaled distance for the main chute slab is shown in Figure 5. The frequency content of each acceleration, strain and computed velocity record was characterized by

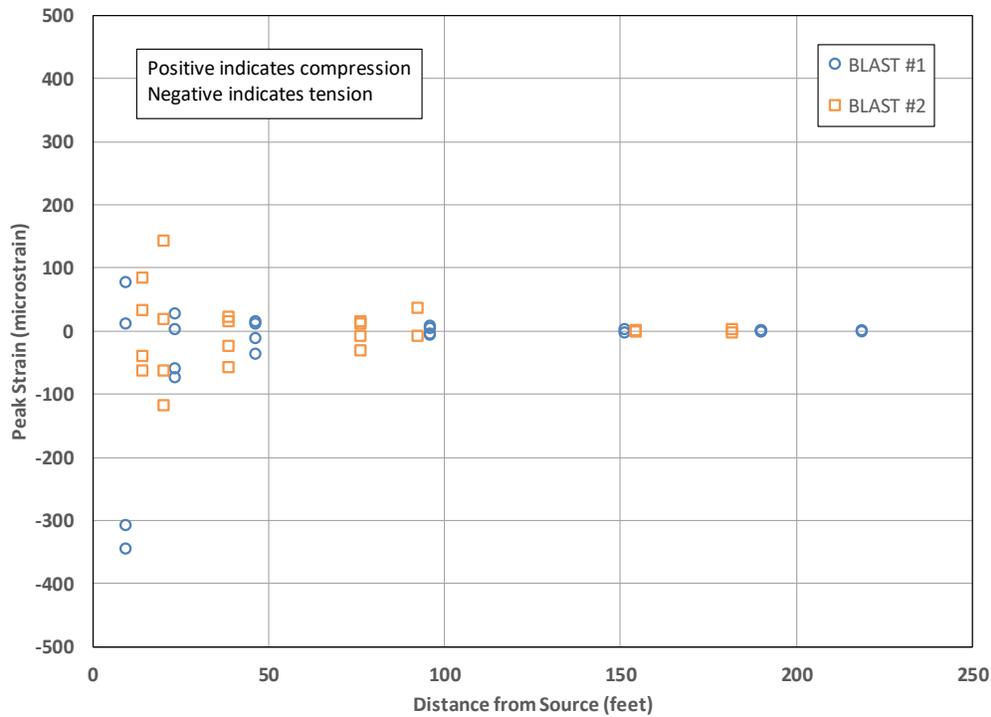
Figure 6. Peak Strain and Distance from Blast Area.

Peak compression and tension strain values were extracted from the strain time history records on the main spillway slab. Figure 6 shows the relationship between peak strain and distance from the blast source, where positive strain indicates compression and negative strain indicates tension. Figure 7 illustrates the exponential decrease in resultant PPV with distance from the blast area. Trends shown in Figure 6 indicate peak strain below 100 microstrain at distances greater than 25 feet and negligible strain beyond a distance of 100 feet. It should be noted that these trends represent general observations, and a peak strain value of 100 microstrain would generally calculate well below a typical allowable stress level for reinforced concrete.

Strain measurements provide a direct way to calculate changes in stress in the concrete main spillway. Figure 8 shows the relationship between peak strain and PPV. Strain relationships shown in Figures 6 and 8 should be considered as characteristic of a concrete slab on grade type structure similar to the subject spillway chute. Results of linear regression relationships are provided on each plot together with R-squared values.

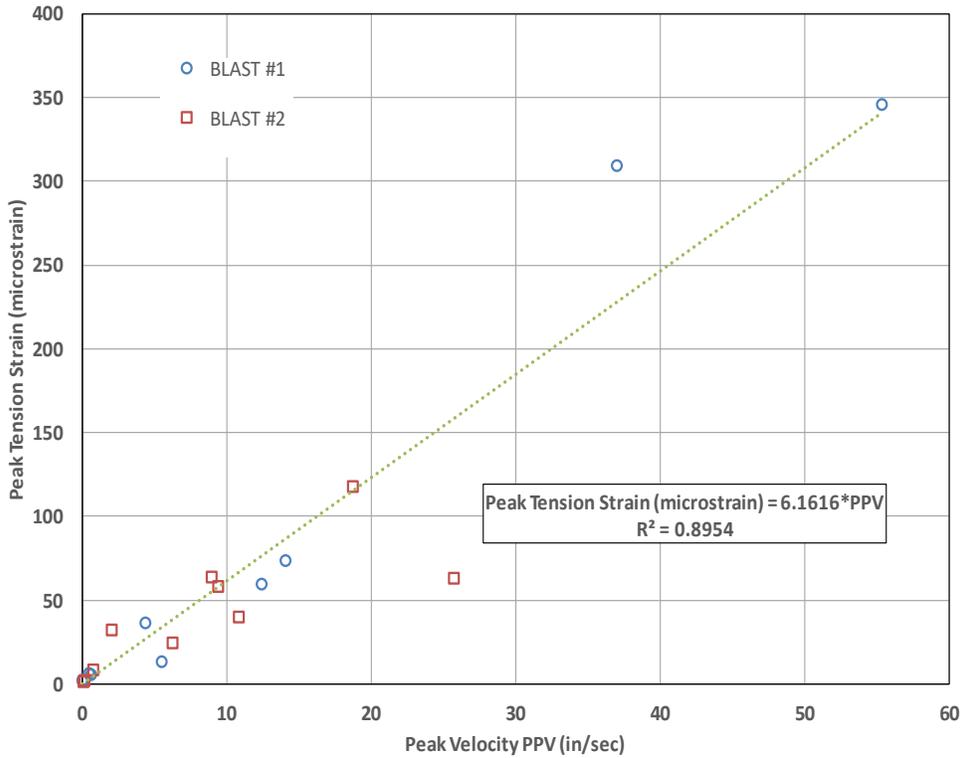
Figure 8. Peak Tension Strain and PPV.

A majority of the data collected includes strain below 100 microstrain. A maximum strain gage reading of 345 microstrain was recorded together with a PPV of 55 ips at a distance of 9.5 feet from the closest blast hole. Additional data points above 100 microstrain would improve the understanding of the linear regression relationship shown in Figure 8.

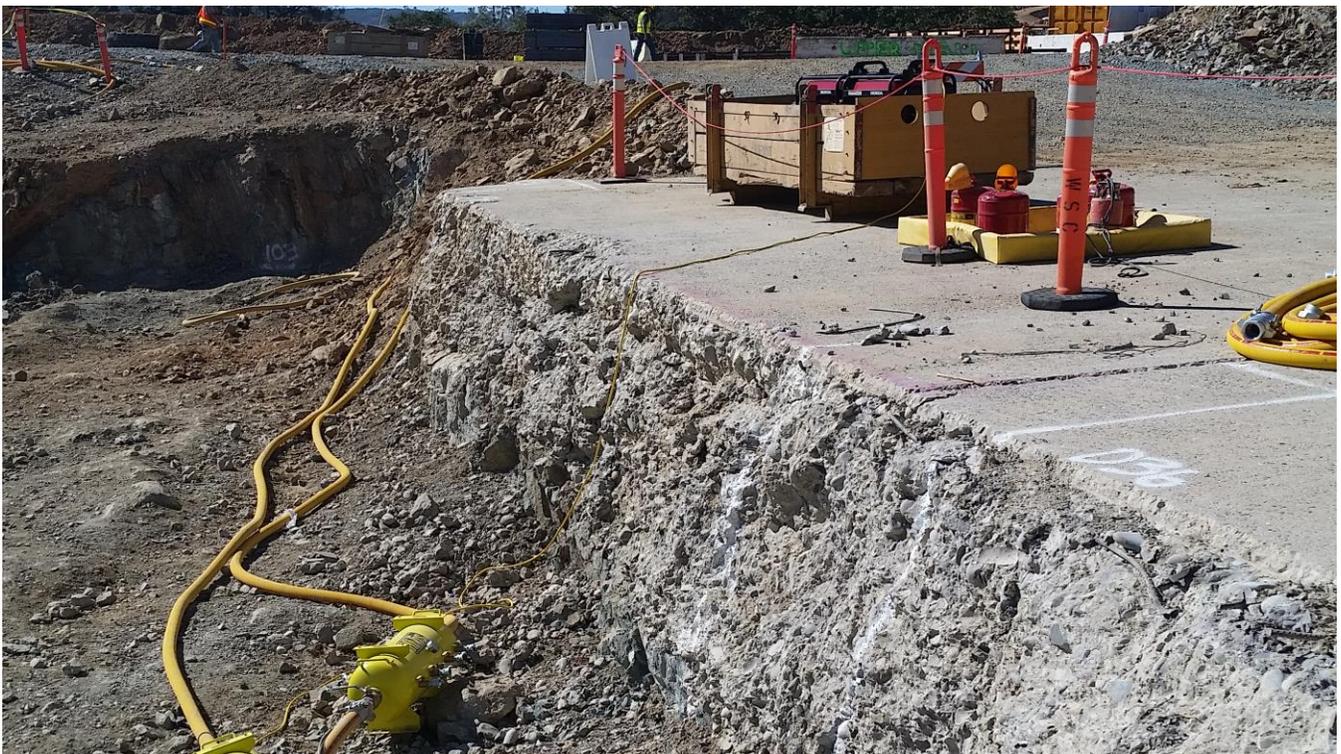
Figure 9. Exposed expansion/contraction joint 18-inches from the nearest blast holes.

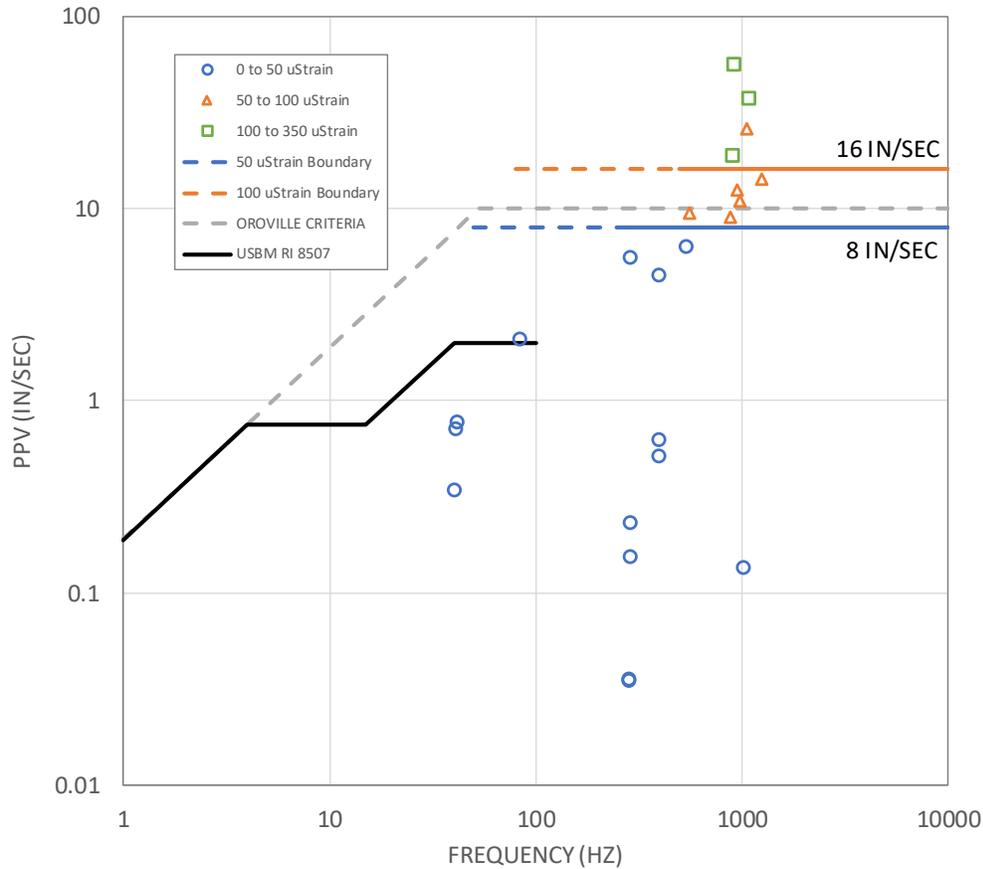
Figure 10. Observed PPV and Frequency at Various Peak Strain Levels.

Results from all monitoring locations with side-by-side strain gages and accelerometers were assembled and organized into three categories based on peak strain levels: a) 0 to 50 microstrain, b) 50 to 100 microstrain, and c) 100 to 350 microstrain. Figure 10 shows PPV and dominant frequency for each strain level category. The relatively small number of data points above 100 microstrain should be noted. Based on the results observed at the Oroville Dam Spillway, no PPV levels below 16 ips were associated with strain levels exceeding 100 microstrain. Specified vibration limits for all blasting at Oroville Dam for concrete aged 10 days or more included a 10 in/s PPV limit and a peak displacement limit of 0.03 inches as shown on Figure 8 for reference. The Oroville Dam criteria (Gray dashed line) includes no peak strain recordings above 100 microstrain. As shown on Figure 9, no visible damage was observed in concrete located at or beyond a construction joint located just 1.5 feet from the closest charges. As indicated earlier, very light decoupled charges were used in the closest holes to prevent direct rupture damage.
